DIEGO GARCIA FLEET MOORINGS UNDERWATER INSPECTION
PROJECT EXECUTION PLAN(U) NAVAL FACILITIES ENGINEERING
COMMAND WASHINGTON DC CHESAPEAKE DIV 1988
CHES/NAVFAC-FP0-8022.5

DIEGO GARCIA FLEET MOORINGS UNDERWATER INSPECTION

PROJECT EXECUTION PLAN

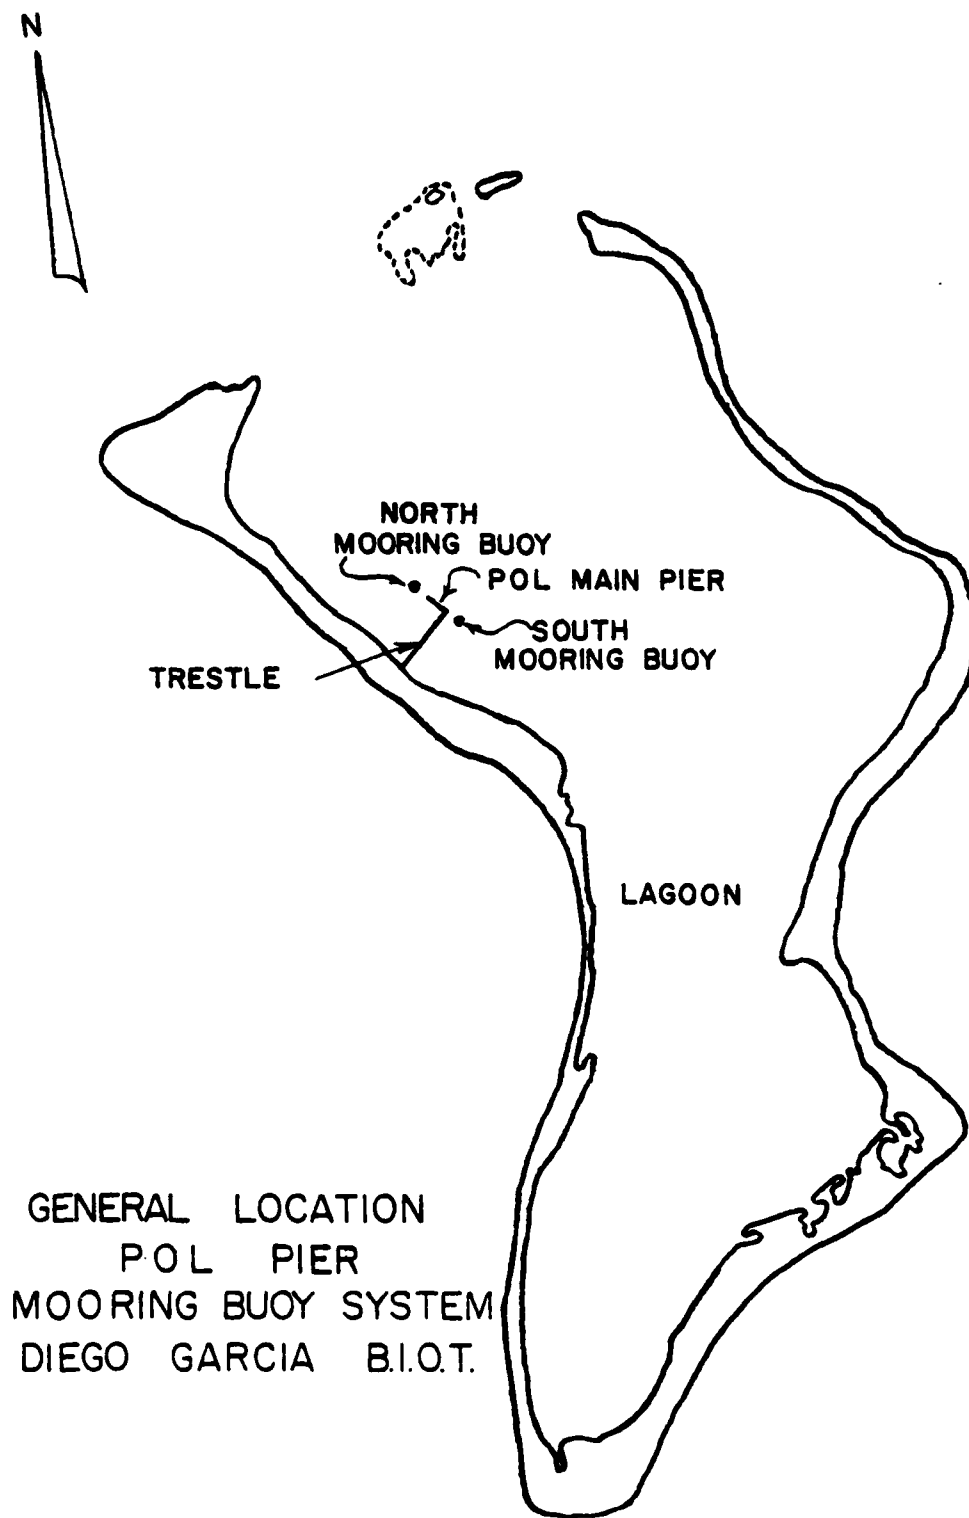
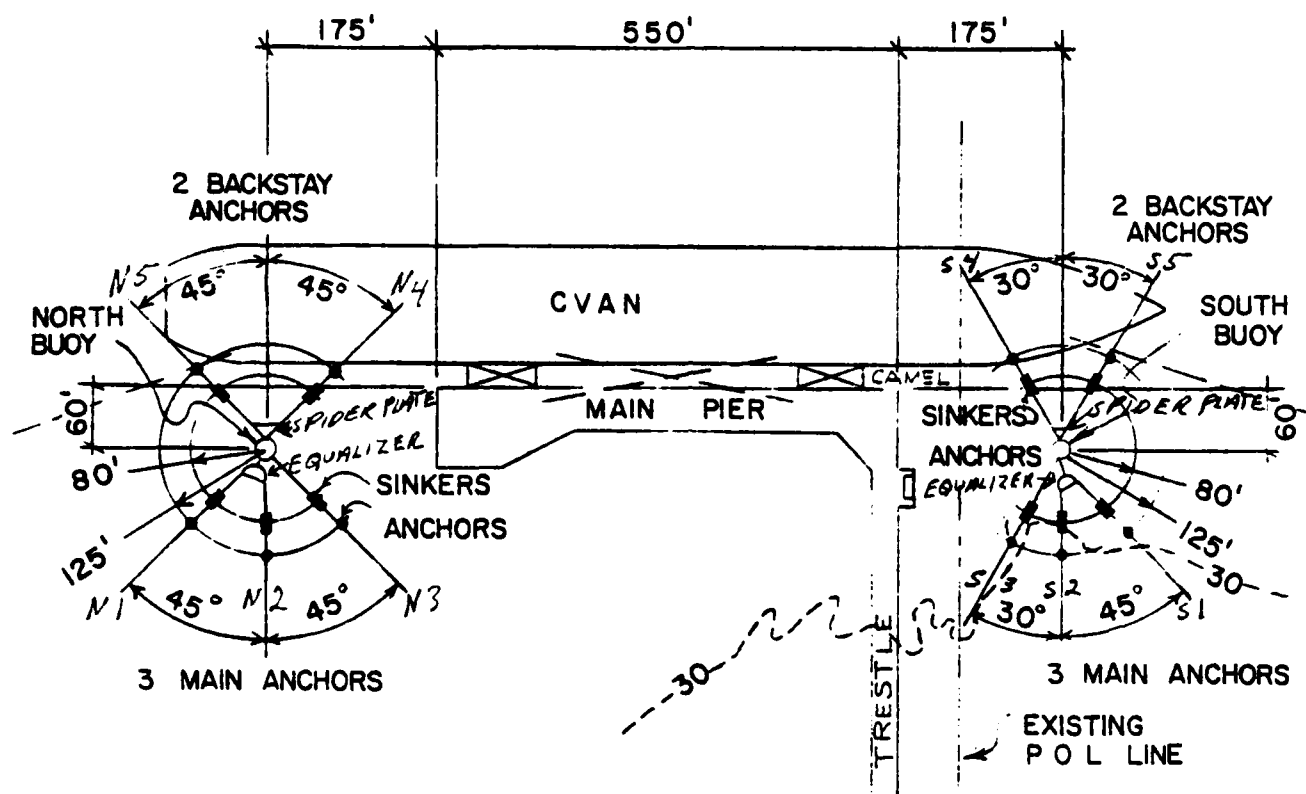
FIGURE 16.

SITE LAYOUT
POL PIER-MOORING BUOY SYSTEM
DIEGO GARCIA B.I.O.T.

8.0 BACKGROUND: During April and May of 1980, two Buoy Dolphin systems were installed in Diego Garcia as part of the POL Pier Project. The POL pier is a 40 feet wide platform by 550 feet long and is connected by a trestle to the shore at its southeasterly end (see Figure 16). The two Buoy Dolphins serve the purpose of securing bow and stern lines of large classes of ships and are located at the two ends of the pier approximately 175 feet from the edge of the pier and set back 60 feet (inshore) from the pier face as shown in Figure 17. Each of the Buoy Dolphin systems consists of a modified MARK II Peg Top Buoy, five chain legs, sinkers, and propellant embedment anchors.

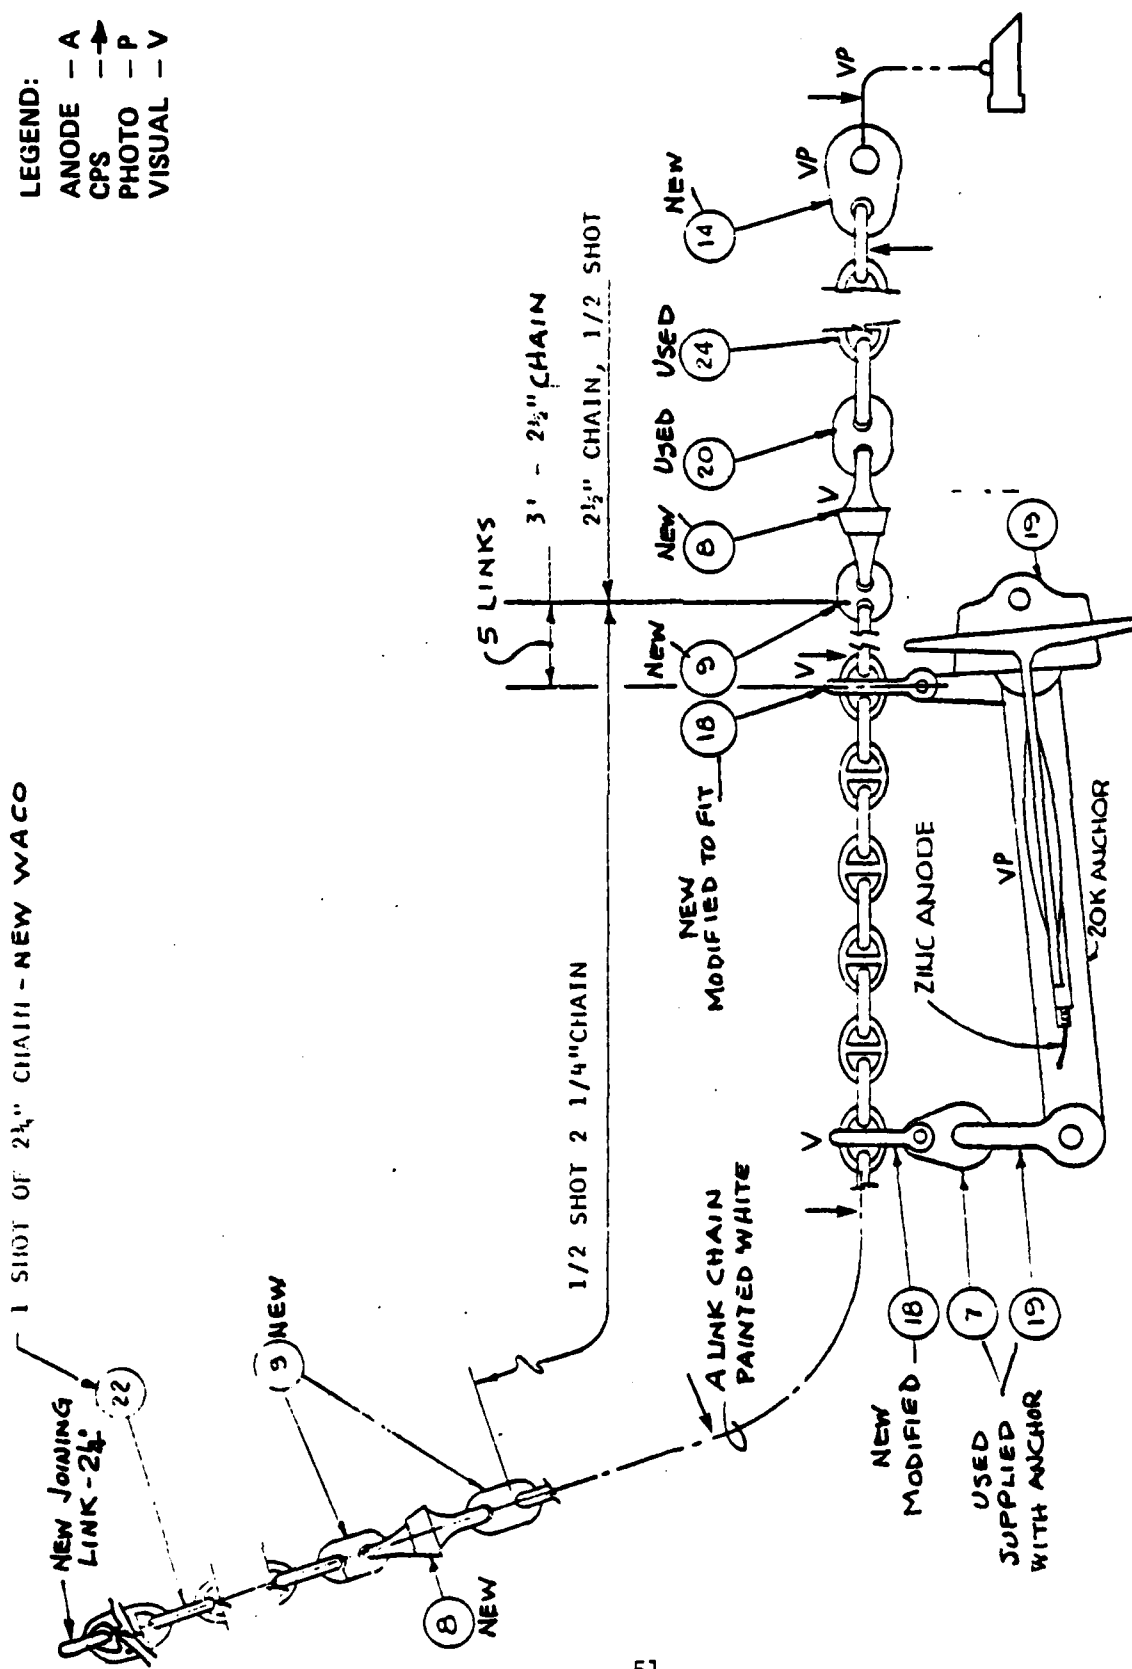
FIGURE 19. LEG - NORTH 1

DOUBLE (EQUALIZER)
 MOORING LEG
 HARDWARE COMPONENTS

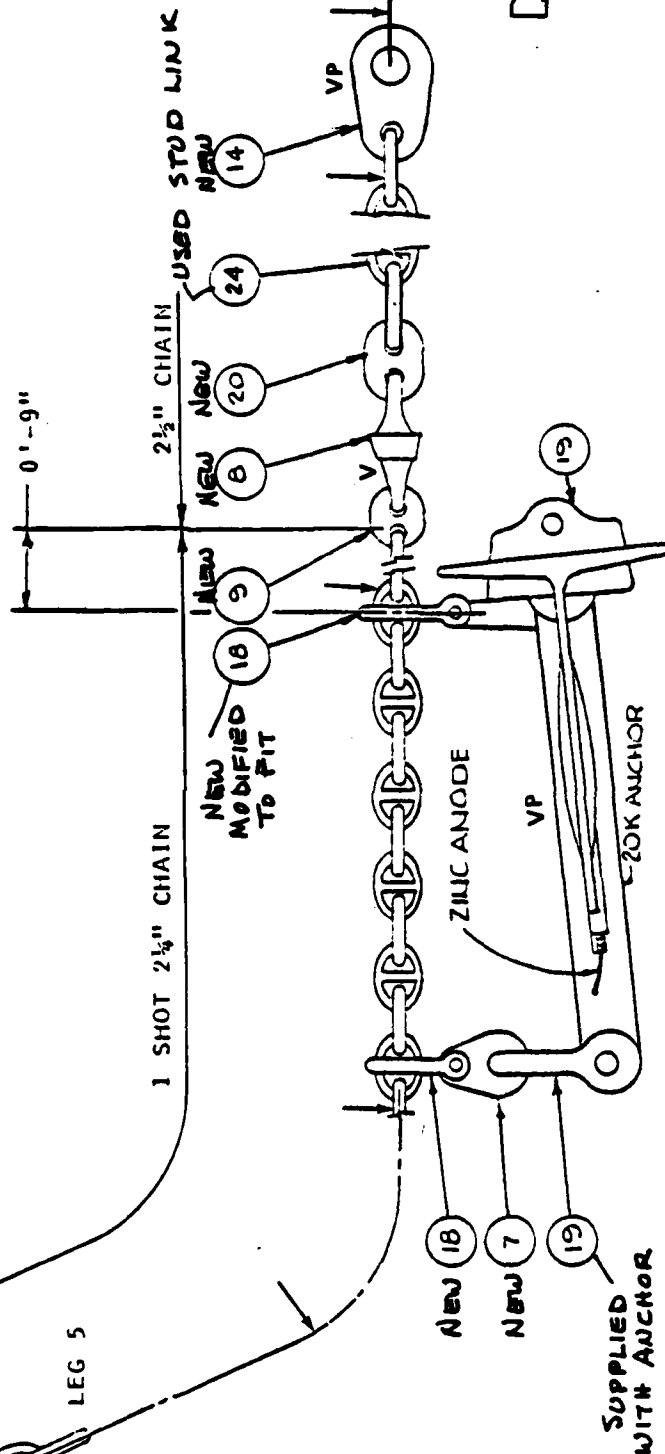
FIGURE 23. LEG - NORTH 5

MOORING LEG HARDWARE
COMPONENTS

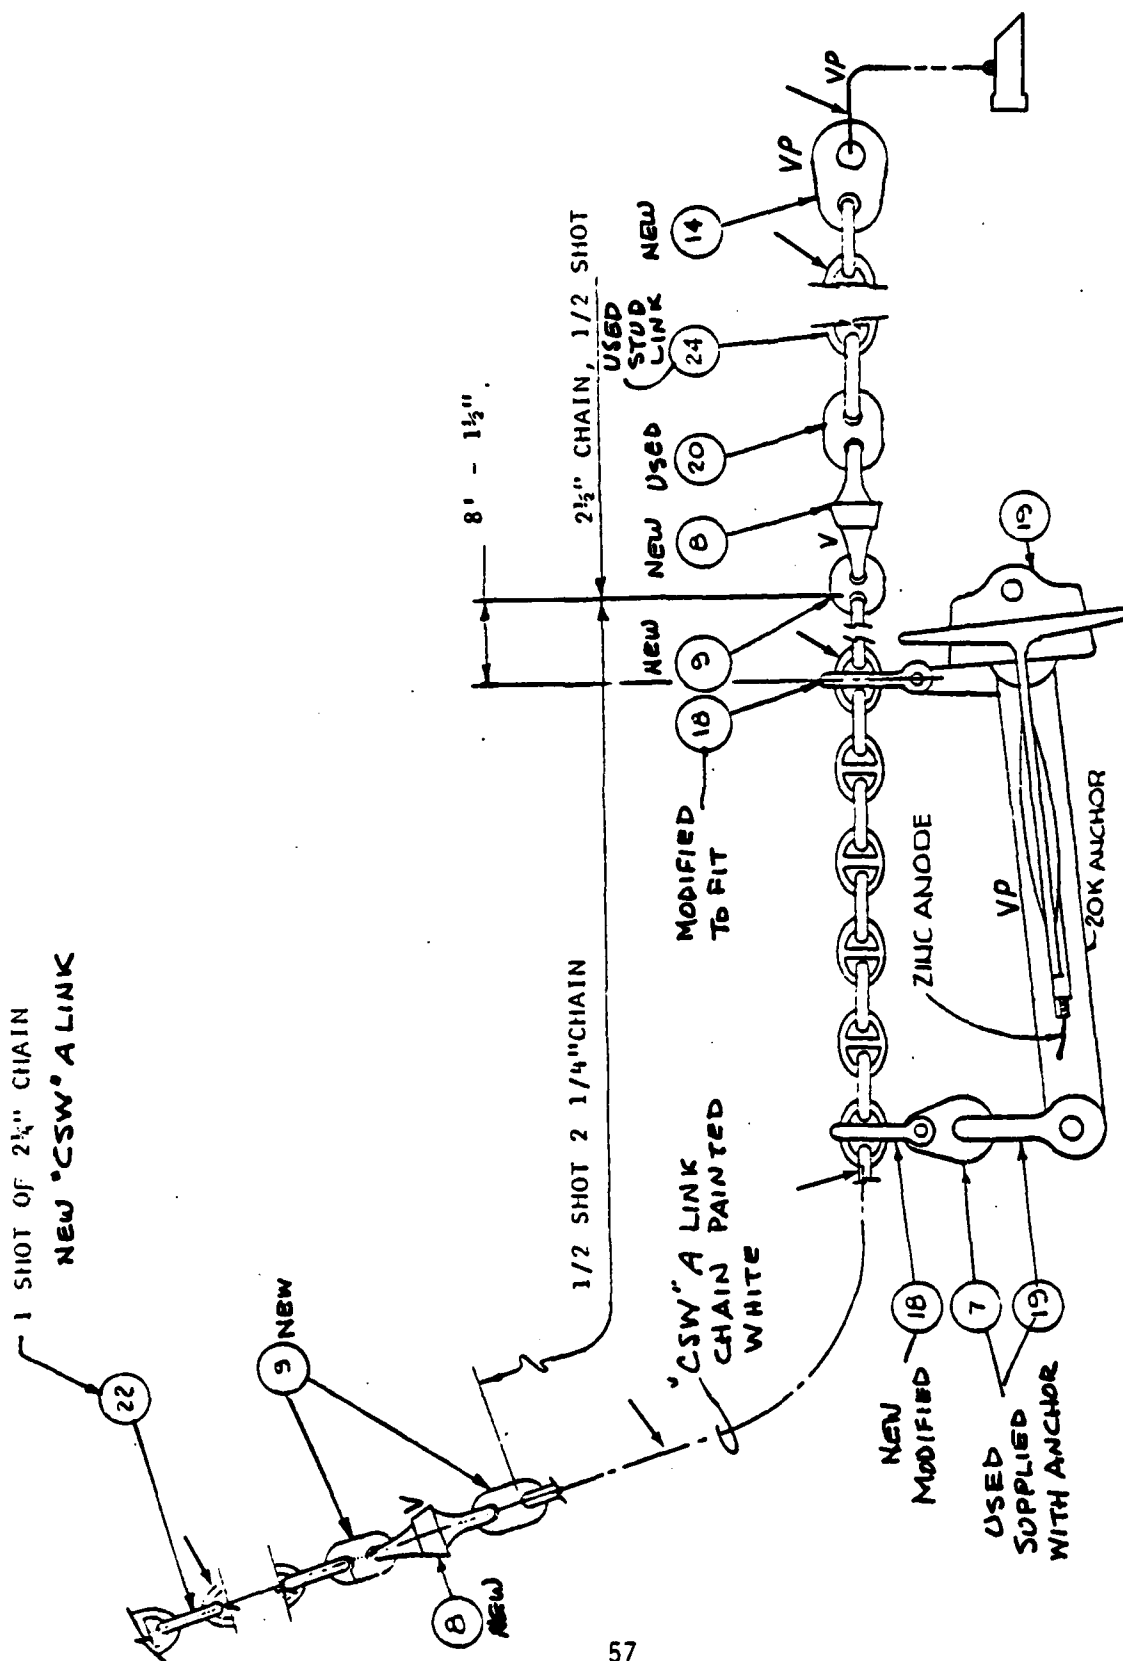
FIGURE 25. LEG - SOUTH 2

MOORING LEG
HARDWARE COMPONENTS

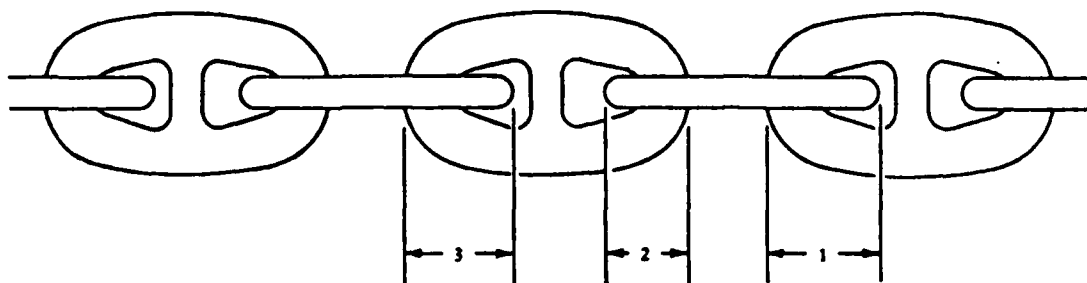
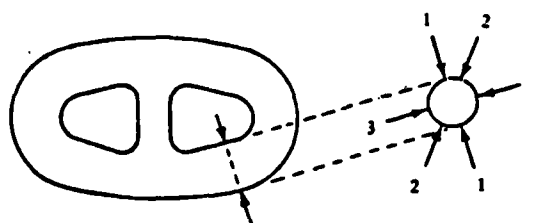
FIGURE A-1. LOCATIONS FOR TAKING CHAIN LINK MEASUREMENTS

Double Link Measurement

Single Link Measurement

4.0 A selective sampling approach shall be used in measuring the POL mooring chain. This consists of measuring the wire diameter of the chain and connecting hardware to determine the amount of corrosion and wear. Chain which is less than 90% of original diameter should be downgraded in classification; chain which is less than 80% of original diameter should be surveyed. Single link measurements on the wire diameter of a single A-link detect corrosion loss; double link measurements made where two A-links contact detect corrosion and wear. Single link measurements are made on three different diameters on the same approximate cross section while double link measurements are used on three adjoining links. Figure A-1 shows the correct ways of taking both single and double link measurements.
